**DEPARTMENT OF TRANSPORTATION****DIVISION OF ENGINEERING SERVICES**

Contract #: 04-0120F4Cty: SF/ALA Rte: 80 PM: 13.2/13.9File #: 69.28**WELDING INSPECTION REPORT****Resident Engineer:**Siegenthaler, Peter**Address:** 333 Burma Road**City:** Oakland, CA 94607**Report No:** WIR-021860**Date Inspected:** 19-Mar-2011**Project Name:** SAS Superstructure**OSM Arrival Time:** 700**Prime Contractor:** American Bridge/Fluor Enterprises, a JV**OSM Departure Time:** 1900**Contractor:** Zhenhua Port Machinery Company, Ltd (ZPMC), Changxing Island **Location:** Shanghai, China**CWI Name:** Zhou Zhong Hai**CWI Present:** Yes No**Inspected CWI report:** Yes No N/A**Rod Oven in Use:** Yes No N/A**Electrode to specification:** Yes No N/A**Weld Procedures Followed:** Yes No N/A**Qualified Welders:** Yes No N/A**Verified Joint Fit-up:** Yes No N/A**Approved Drawings:** Yes No N/A**Approved WPS:** Yes No N/A**Delayed / Cancelled:** Yes No N/A**Bridge No:** 34-0006**Component:** OBG Segments**Summary of Items Observed:**

On this date Caltrans OSM Quality Assurance (QA) Inspector, Dan Hernandez was present during the times noted above to observe the fit up, welding and related activities associated

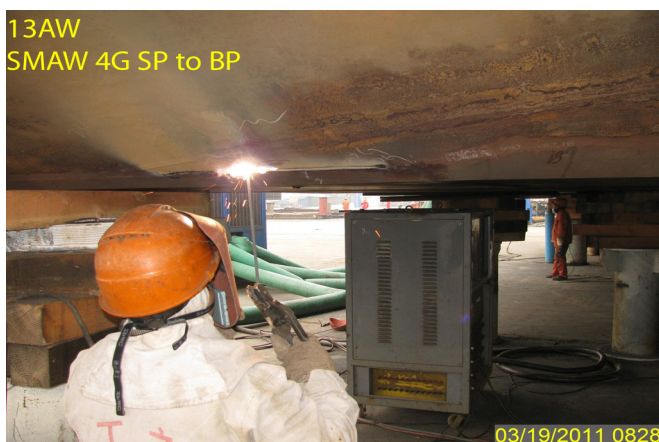
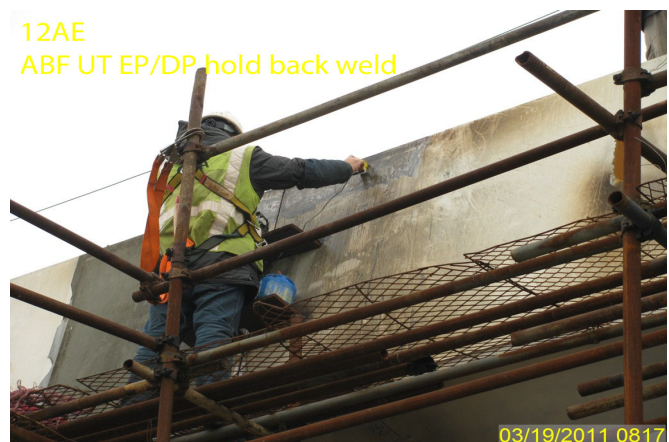
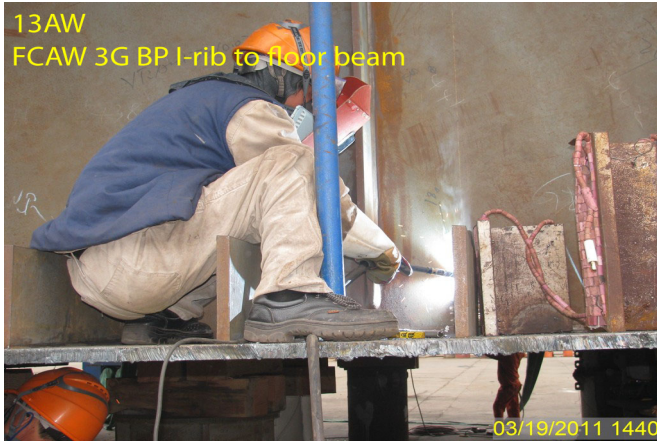
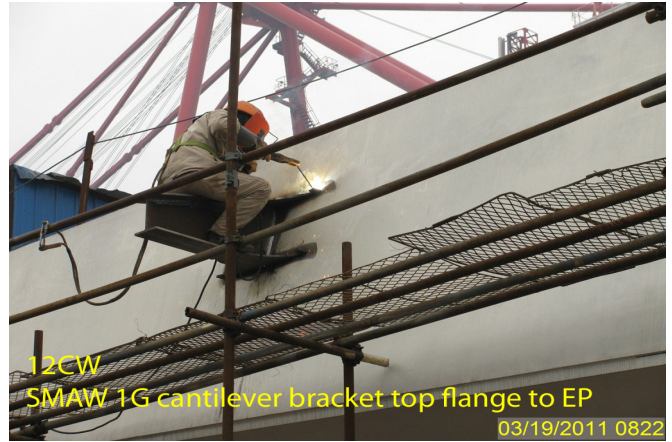
This QA Inspector observed Shielded Metal Arc Welding (SMAW) in progress of a UT repair on a Complete Joint Penetration (CJP) weld joint. The Weld joint is designated SEG3002M-090, Longitudinal Diaphragm to Bottom plate hold back weld. The welder is identified as #044504 and was observed welding in the 2G (horizontal) position using approved Welding Procedure Specification WPS-345-2G (2F)-FCM-repair-1 for WR20464.

This QA Inspector observed Shielded Metal Arc Welding (SMAW) in progress of a Complete Joint Penetration (CJP) weld joint. The Weld joint is designated OBW12C-018, Cantilever Bracket top flange to Edge Plate at panel point 114.5. The welder is identified as #046709 and was observed welding in the 1G (flat) position using approved Welding Procedure Specification WPS-B-P-2211-TC-U4b-FCM-1.

This QA Inspector observed ABF personnel performing Ultrasonic Testing on the Longitudinal Diaphragm to Bottom Plate hold back weld, cross beam and counter weight side at east end of segment.

This QA Inspector observed ABF personnel performing Magnetic Particle Testing on the root pass after back gouge of Cantilever Bracket top and bottom flange to Edge Plate CJP weld joint at panel point 112.5.
